# Before & AFTER

## Century Avionics

**Aircraft Type:** King Air 200

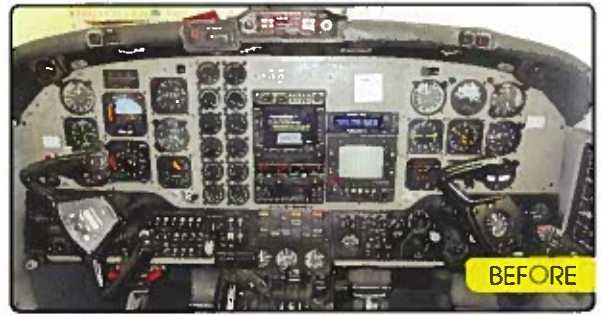
Century Avionics had to remove the complete instrument panel for the installation.

We removed the complete instrument panel for the installation, which gave us access to all the old wiring behind the instrument panel. We removed the unneeded wiring and reorganized the rest. The integration between the Garmin G600, L3 ESI-500 and the S-TEC

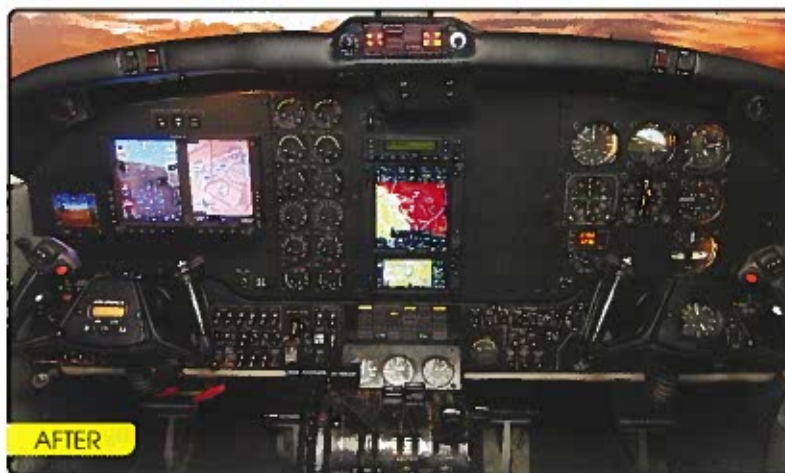
A more-reliable, solid-state glass cockpit was installed for better situational awareness, reliability and minimized downtime.

The aircraft is mainly used for medivac in Africa. The primary objective was to remove the analog, steam-driven gauges and install a more-reliable, solid-

state glass cockpit for better situational awareness, reliability and minimized downtime.
